Technical Memorandum

Surface Impoundment Cap Evaluation for Erosion

**Gulfco Marine Maintenance Superfund Site
906 Marlin Avenue
Freeport, Brazoria County, Texas
EPA Identification No. TXD0055144539**

December 2010
Revision 01
EA Project No. 14342.67

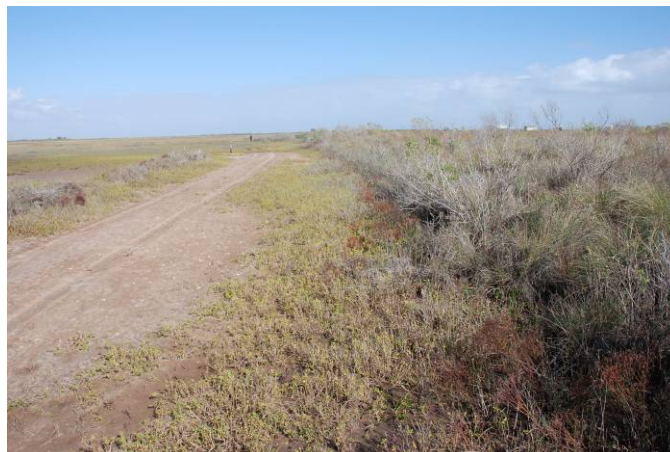
The elevation of the surface impoundment cap is approximately 2 feet higher than the surrounding existing natural surface grade. The existing cap is approximately 2.5 to 3.5 feet thick. The clay cap appeared to be in good condition with no surface cracking during the site investigation. The photo below shows the typical elevation differences between the cap, to the right, and the surrounding areas.

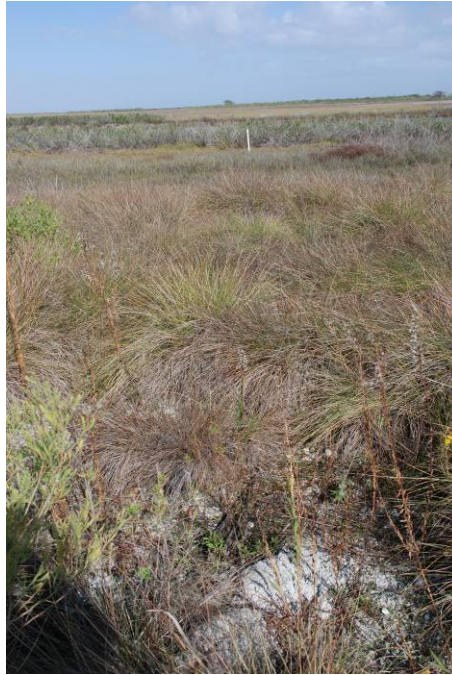
The surface of the clay cap is covered with a layer of oyster shells and vegetation. Cap vegetation consists of mostly grasses with some brush. The majority of the brush is located along the perimeter of the cap with isolated patches within the interior portions of the cap. The photo below shows typical cap vegetation.

There is no obvious maintenance of the cap as evidenced by the presence of woody vegetation around the perimeter of the cap and on a few areas on top of the cap. The roots of woody vegetation could compromise the clay layer of the cap and allow infiltration and contribute to migration of contaminants away from the confines of the former impoundment.

Therefore, the current impoundment cap clay layer does not meet the requirements for a Class 1 impoundment, nor does the current surface layer. The cap is vegetated but woody growth needs to be cut or removed.

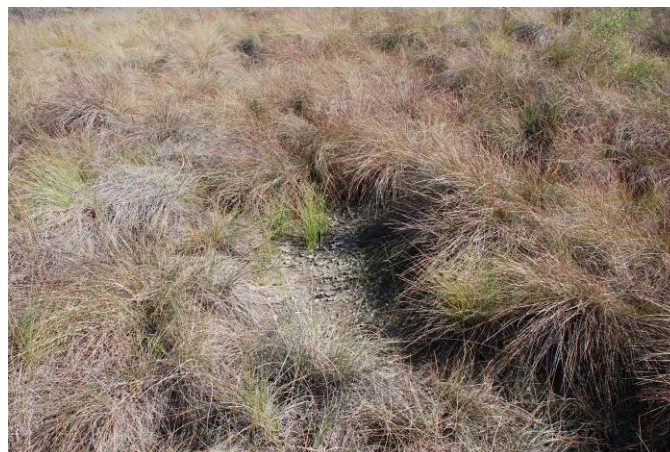
Evidence of vehicular traffic along the perimeter of the cap was observed during the site investigation. Wheel tracks have formed ruts in portions of the vegetation along the western side of the cap. The rutting was generally no more than 3 inches deep with one location found to be approximately 6 inches deep. The photo below is an example of typical vehicle paths through the ground cover.

Even though there is no evidence of erosion, the obvious rutting of the cap on the western edge has not been repaired and could also lead to compromise of the clay layer.

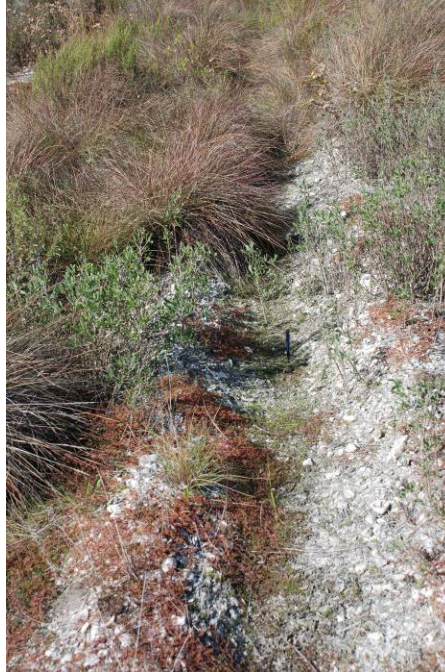
The photo below details the area of deepest rutting (approximately 6-inches).
